Traylor Bros., Inc. Crane Audit

A-75

Al Larson boat yard

4/1/15, 1:28 PM

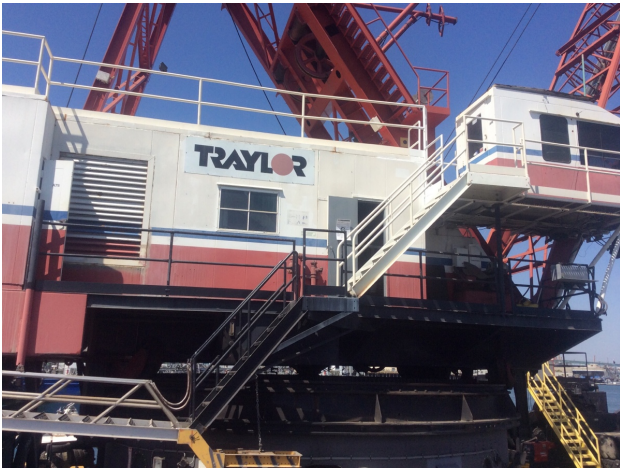
Appendix 1

Question	Response	Details
Crane Information:		Score:(115/140) 82.14%
Description:	Other	
	American Clyde 28	
<div>

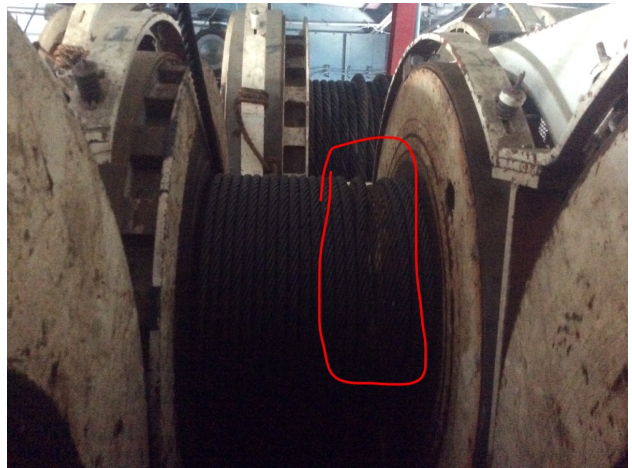
Appendix 2

Question	Response	Details
Wire Rope Condition:	At Risk	Cable needs rewrapped.
