Freeze Thaw Resistance of Pervious Concrete

NRMCATM
NATIONAL READY MIXED
CONCRETE ASSOCIATION

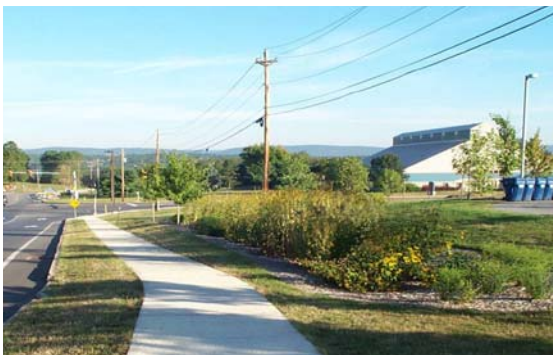
The project is a heavily used sidewalk approximately 300 feet long. There is very heavy foot traffic as it is next to a football stadium. The pervious concrete is 4” thick with an 8” large, clean-washed aggregate base on un-compacted sub grade. The location undergoes an average of about 121 cycles/year. The average daily temperature stays below freezing for 90 consecutive days (on average) and there is winter precipitation. So the climate is considered as a hard wet freeze. There is very little maintenance. The current performance is good. Mix design is based on Florida concrete association w/ cold weather additive.

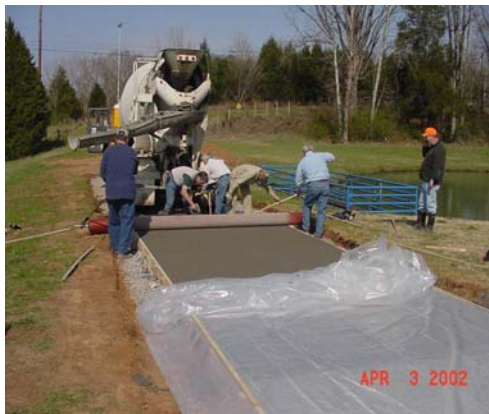
The project involves a walking path and a parking area. The walking path has 5" of pervious concrete over a 5" stone base, on top of underlying clay soil. The parking area has 6" of pervious concrete over a 5" stone base; it includes some drainpipes. There are about 1200-1300 cubic yards in the parking area, while the walking path is 1/3 mile long. The location undergoes an average of about 90 cycles/year. However, the climate is not a hard freeze, as the average daily temperature does not drop below freezing point very often. There is precipitation during winter so the location is considered as a wet freeze. There was some vacuum sweeping after a heavy rainstorm deposited mud on the pathway. The current performance is good and there is no clogging or raveling.

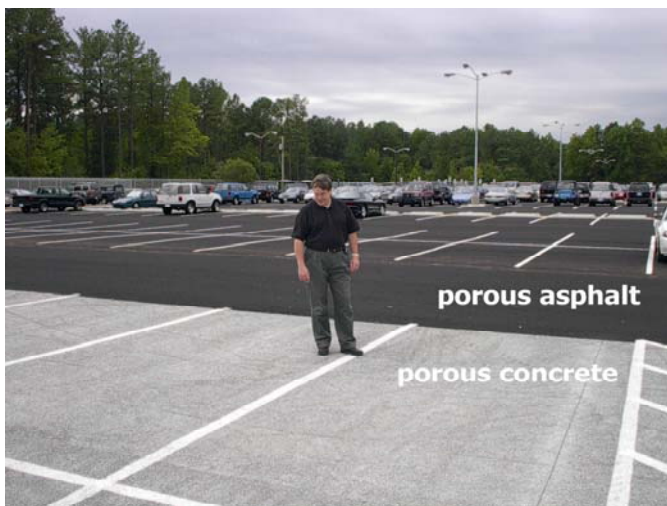
This project is a heavily used commuter parking lot – 150 spaces @ Friday Ctr. and 75 spaces @ Estes. The pervious concrete is 5” thick, over an 18” large, clean-washed aggregate base on un-compacted sub grade. The project involved 1,500 cubic yards of pervious concrete and won the American Council of Engineering Companies (ACEC) – Grand Conceptor Award. The location undergoes on an average about 90 cycles/year. However, the climate is not a hard freeze, as the average daily temperature does not drop below freezing point very often. There is precipitation during winter so the location is considered as a wet freeze. There is very little maintenance. After two winters of above average freeze thaw cycles, the current performance is good. The mixture design is proprietary.

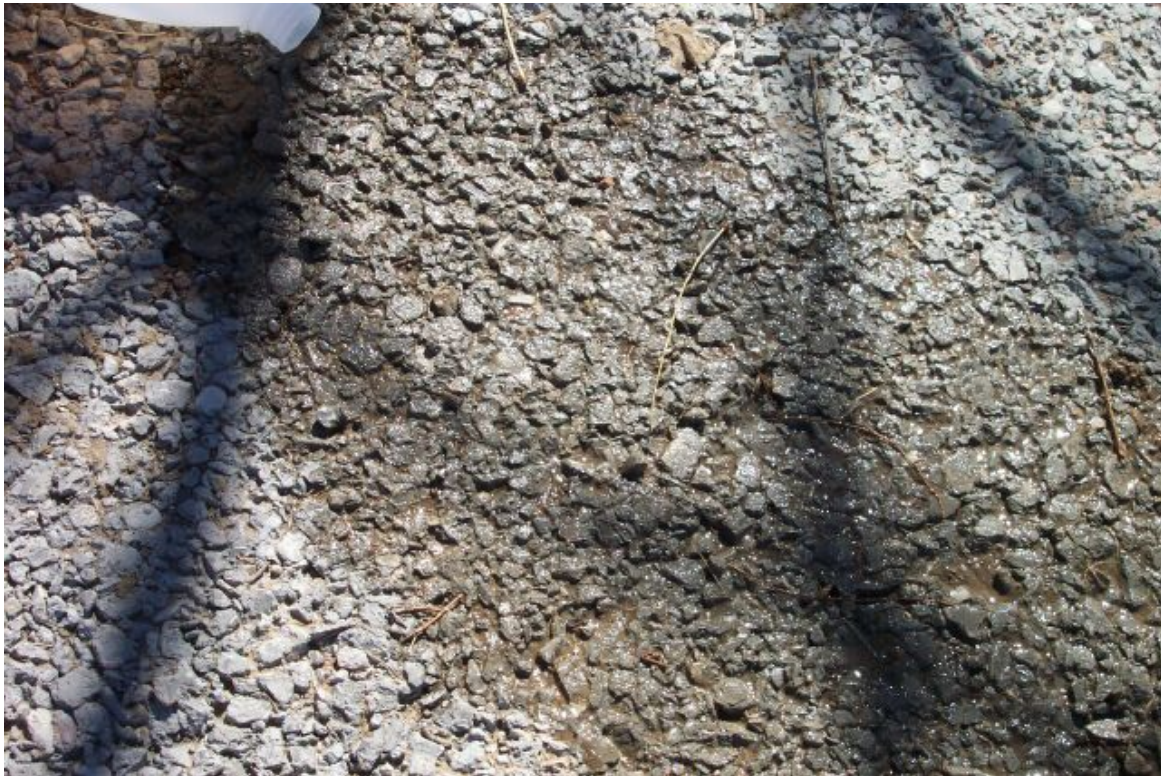
The project is a parking lot for a small company. The lot is about 600 sq. yards and the traffic is pickups, SUVs and cars (all four-wheelers). The material was placed 4” to 6” thick and leveled with a regular garden rake. No drainpipes or curbs and gutters. It was compacted with a walk-behind flat plate compactor. The material was cheaper than concrete but more expensive than gravel base. The location undergoes an average of about 212 cycles/year. The average daily temperature stays below freezing for 62 consecutive days (on average) but there is very little precipitation during this period and only about 10 inches of rain throughout the year. So the climate is considered a hard dry freeze with very high freeze thaw cycling. There is no annual maintenance on this project and, after 13 years, the performance has been good. Over the past 13 years the parking lot has filled with mud that drops off the vehicles when parked. Two years ago, after a 4” rain caused flooding of the town, the parking lot had no ponded water. There are still voids to drain the water. There is some raveling of the coarse aggregate and clogging due to the mud. The parking lot has been through many snows and it has not turned into a pile of loose rock. When it was a new parking lot, the snow was pushed off and the sun came out and there was no ice build up on surface. The snow tends to melt quickly. Mixture design was cement = 300 lbs / cu.yd; coarse aggregate # 57 – 1 “ minus size 2570 lbs / cu.yd; water about 20 gals / cu.yd. Plastic unit was about 106 pcf, no entrained air or water reducer or fly ash. % void based on ASTM C-138 20 to 24 %. When filling a 4”x8” cylinder with pervious and then adding water 2” of water can be placed into the cylinder. And it

will fill the voids. Compressive strength after 28 days about 1000 psi. No special curing of the pervious. Just placed and opened for traffic.

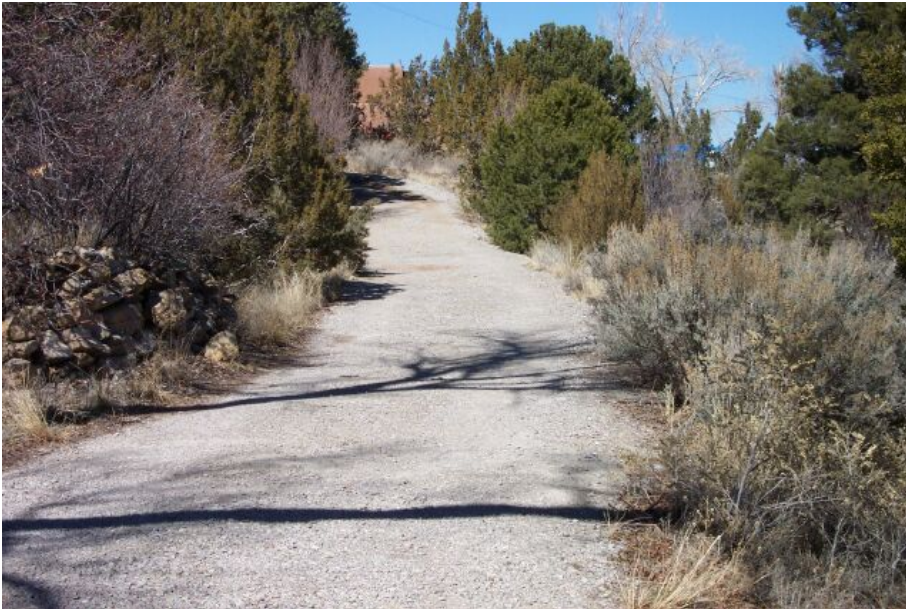
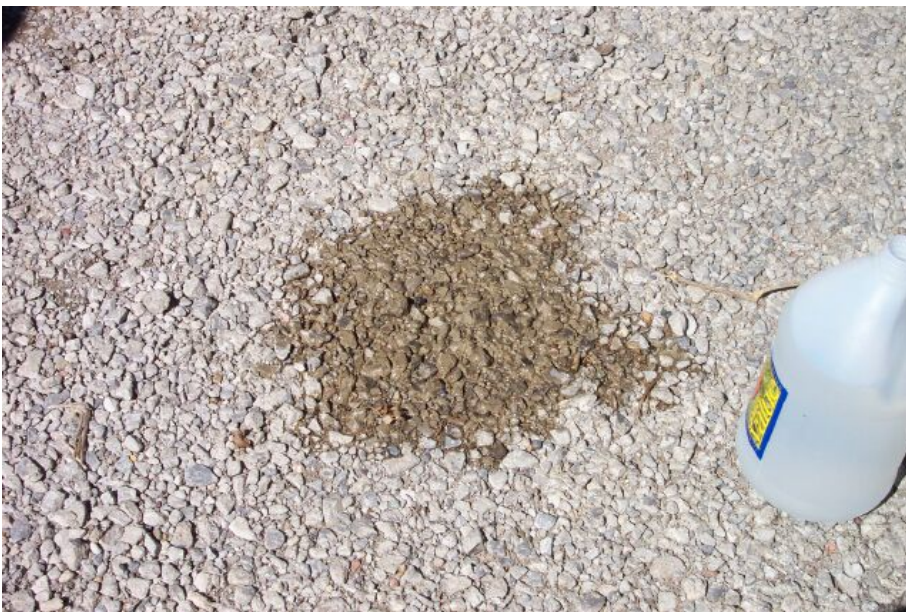
The pervious concrete was placed as a driveway surface to keep a rustic look. The driveway is about 400 feet long and 10’ wide. The traffic is pickups, SUVs, and cars (all four-wheelers), which have traveled up and down the hill every day for 11 years. The material was placed 4’ to 6” thick and leveled with a regular garden rake. It was compacted with a walk-behind flat plate compactor. There are no drainpipes or curbs and gutters. The location undergoes an average of about 212 cycles/year. The average daily temperature stays below freezing for 62 consecutive days (on average) but there is very little precipitation during this period and only about 10 inches of rain throughout the year. So the climate is considered a hard dry freeze with very high freeze thaw cycling. There is no annual maintenance on this project and, after 11 years, the performance has been good. There is loose rock on the edge and some clogging where rain has caused soil to run onto the pervious. We placed a yellow color in the pervious when installed but it is not there now. The owner has a science background and is pleased with the results. The neighbors have placed base gravel twice and it continues to go down into the mud. The material was cheaper than concrete but more expensive than gravel base. Mixture design was cement = 300 lbs / cu.yd; coarse aggregate # 57 – 1” minus size 2570 lbs / cu.yd; water about 20 gals / cu.yd. Plastic unit was about 106 pcf, no entrained air or water reducer or fly ash. % void based on ASTM C-138 20 to 24 % . When filling a 4”x8” cylinder with pervious and then adding water 2” of water, can be placed into the cylinder. And it will fill the voids. Compressive strength after 28 days about 1000 psi. No special curing of the pervious. Just placed and opened for traffic.

The pervious fell apart on an incline of 10% where it was about 2" thick and cars and trucks would spin going up the hill.

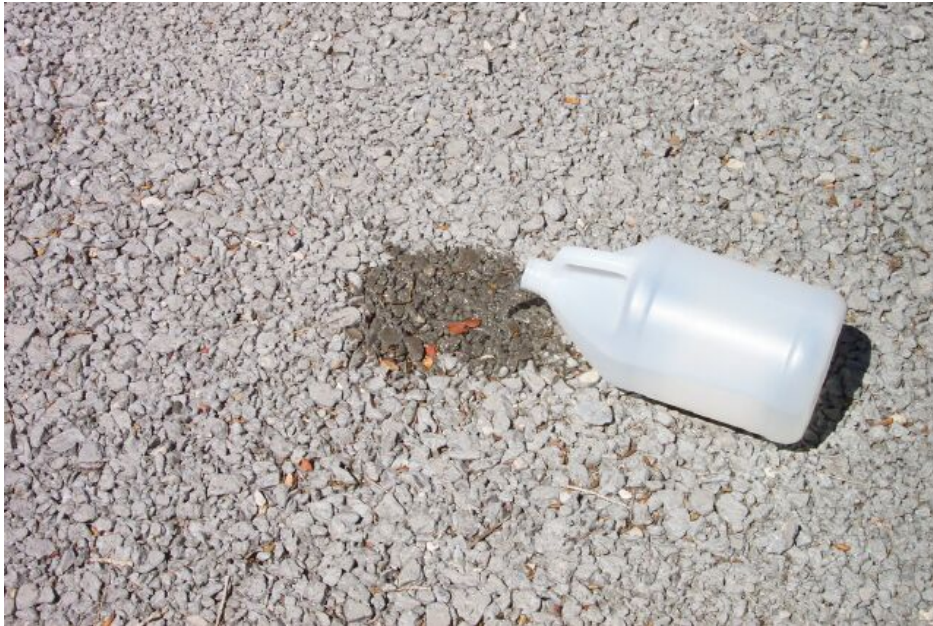
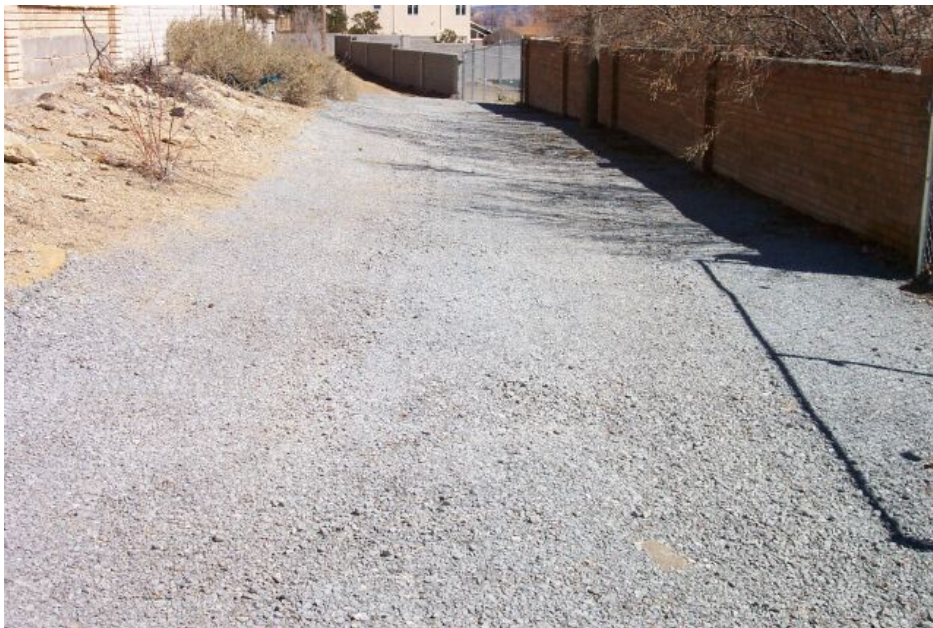
The pervious concrete is about 400 sq. yards. The traffic is a garage truck pickup, an SUV and a dog (all four-wheelers). The material was placed 4" to 6" thick and leveled with a regular garden rake. It was compacted with a walk-behind flat plate compactor. No drainpipes or curbs and gutters. The location undergoes an average of about 212 cycles/year. The average daily temperature stays below freezing for 62 consecutive days (on average) but there is very little precipitation during this period and only about 10 inches of rain throughout the year. So the climate is considered a hard dry freeze with very high freeze thaw cycling. There is no annual maintenance on this project and, after 10 years, the performance has been good. There is more ground cover to keep the mud down and vehicles park but do not fall into the mud. Part of the pavement is on a hill and it slid some. There is one crack that we have noted. The pervious lot has been through many snows and it has not turned in to a pile of loose rock. Mixture design was cement = 300 lbs / cu.yd; coarse aggregate # 57 – 1" minus size 2570 lbs / cu.yd; water about 20 gals / cu.yd; plastic unit we about 106 pcf. No entrained air or water reducer or fly ash. % void based on ASTM C-138 20 to 24 % . When filling a 4"x8" cylinder with pervious and then adding water, 2" of water can be placed into the cylinder. And it will fill the voids. Compressive strength after 28 days about 1000 psi. No special curing of the pervious. Just placed and opened for traffic.

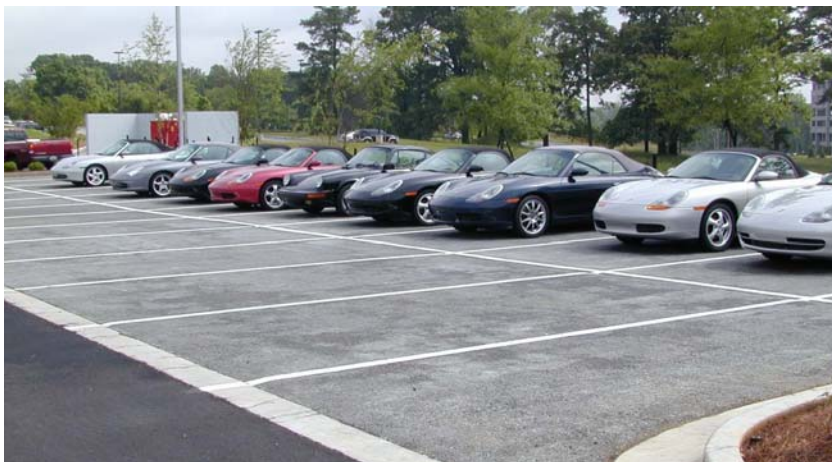
The pervious concrete project is a Porsche dealership parking lot with a total area of 12,000 square feet. It involves 5” thick pervious concrete over 4” thick layer of #57 stone over geotextile. Curb and gutter with flush curb separating asphalt. The parking lot is in good condition and there is no annual maintenance. The location undergoes an average of about 50 cycles/year. However, the climate is not a hard freeze, as the average daily temperature does not drop below the freezing point very often. There is precipitation during winter so the location is considered as a wet freeze. There is no annual maintenance and the parking lot is in good condition. The concrete mixture design is 89 stone, no air, and 119 lb per CF.
